NASA TN D-6519

CORROSION STUDY OF BARE AND COATED STAINLESS STEEL

by J. D. Morrison

John F. Kennedy Space Center

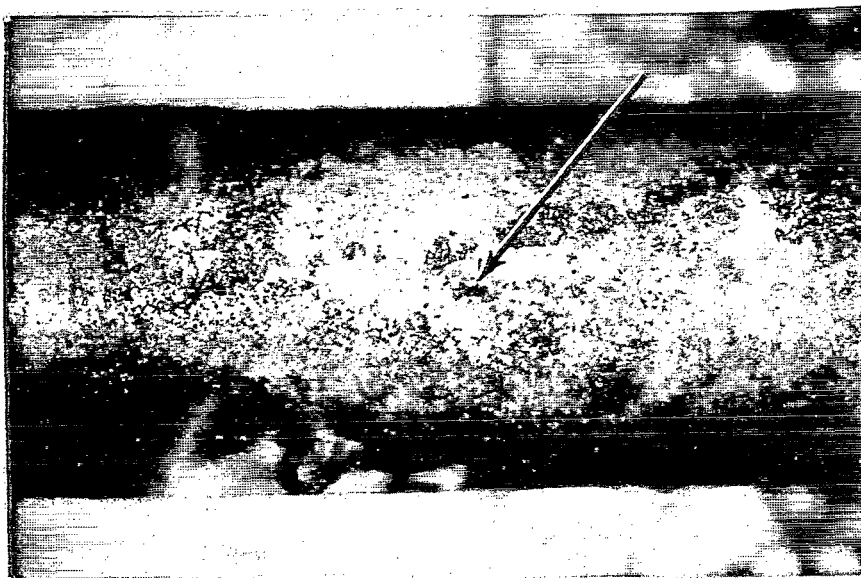
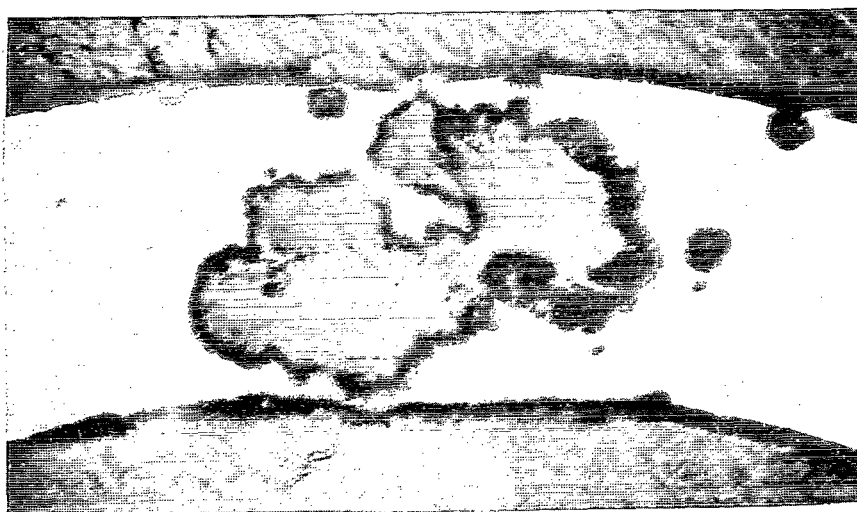
Figure 1. Perforation of Stainless Steel Tubing Used in High-Pressure Oxygen System on Astronauts' Transfer Van

Figure 1 shows an enlarged view of the surface of a 0.955-cm (0.375-inch)-diameter tube with the perforation indicated by an arrow (View A). A cross-section through the tubing wall in the perforation area is also shown (View B) enlarged to 50X. This failure occurred in a high-pressure oxygen line on the Astronauts' Transfer Van.

Perforation on tube surface indicated

Cross-section through perforation in tubing wall

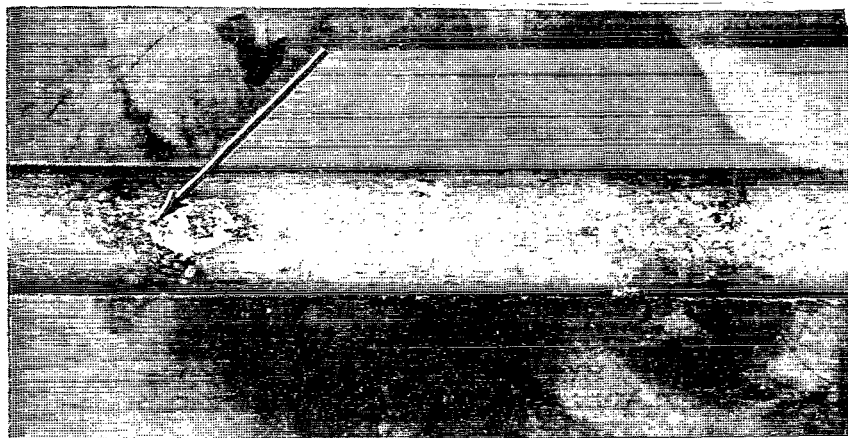
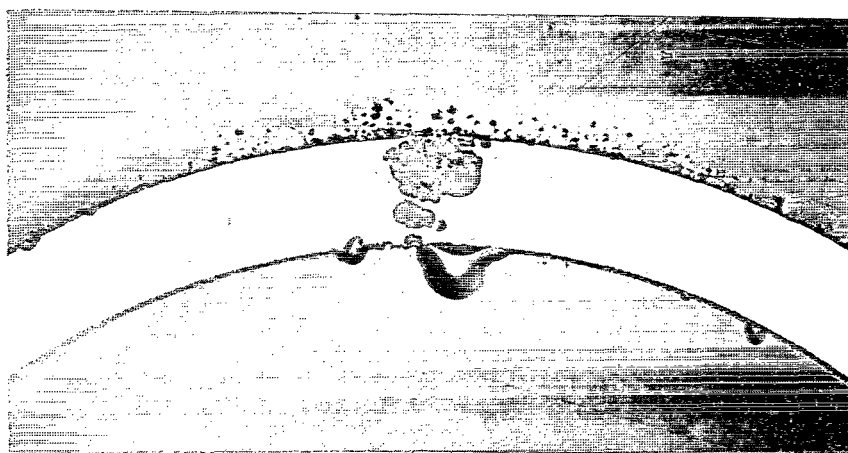
Figure 2. Perforation of Stainless Steel Tubing Used in Gaseous Hydrogen Line at Complex 34

Figure 2 similarly shows the surface and cross-section in the perforated area of a section of stainless steel tubing that was used in a gaseous hydrogen line at Complex 34. A ring of corrosion product can be noted on the tube surface around the perforated point in View A. A microsection through the perforation is shown in View B.

Perforation point and surrounding surface corrosion product

Cross-section through perforation in tubing wall

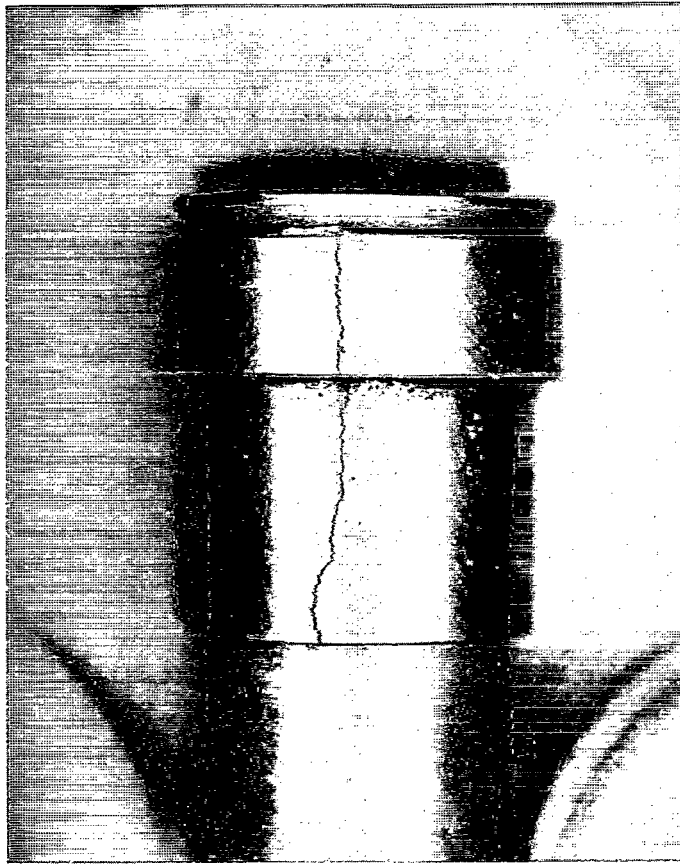
Figure 3. Cracked B-Nut Sleeve from Control Console Line,
Mobile Launcher Service Arm 8, Complex 39

Figure 3 illustrates a typical example of stress-corrosion failure. The sample shown is a stainless steel B-nut sleeve containing a longitudinal crack extending the full length of the sleeve. This sample has been removed from a console line used on a mobile launcher service arm.

Sleeve full-length stress corrosion crack

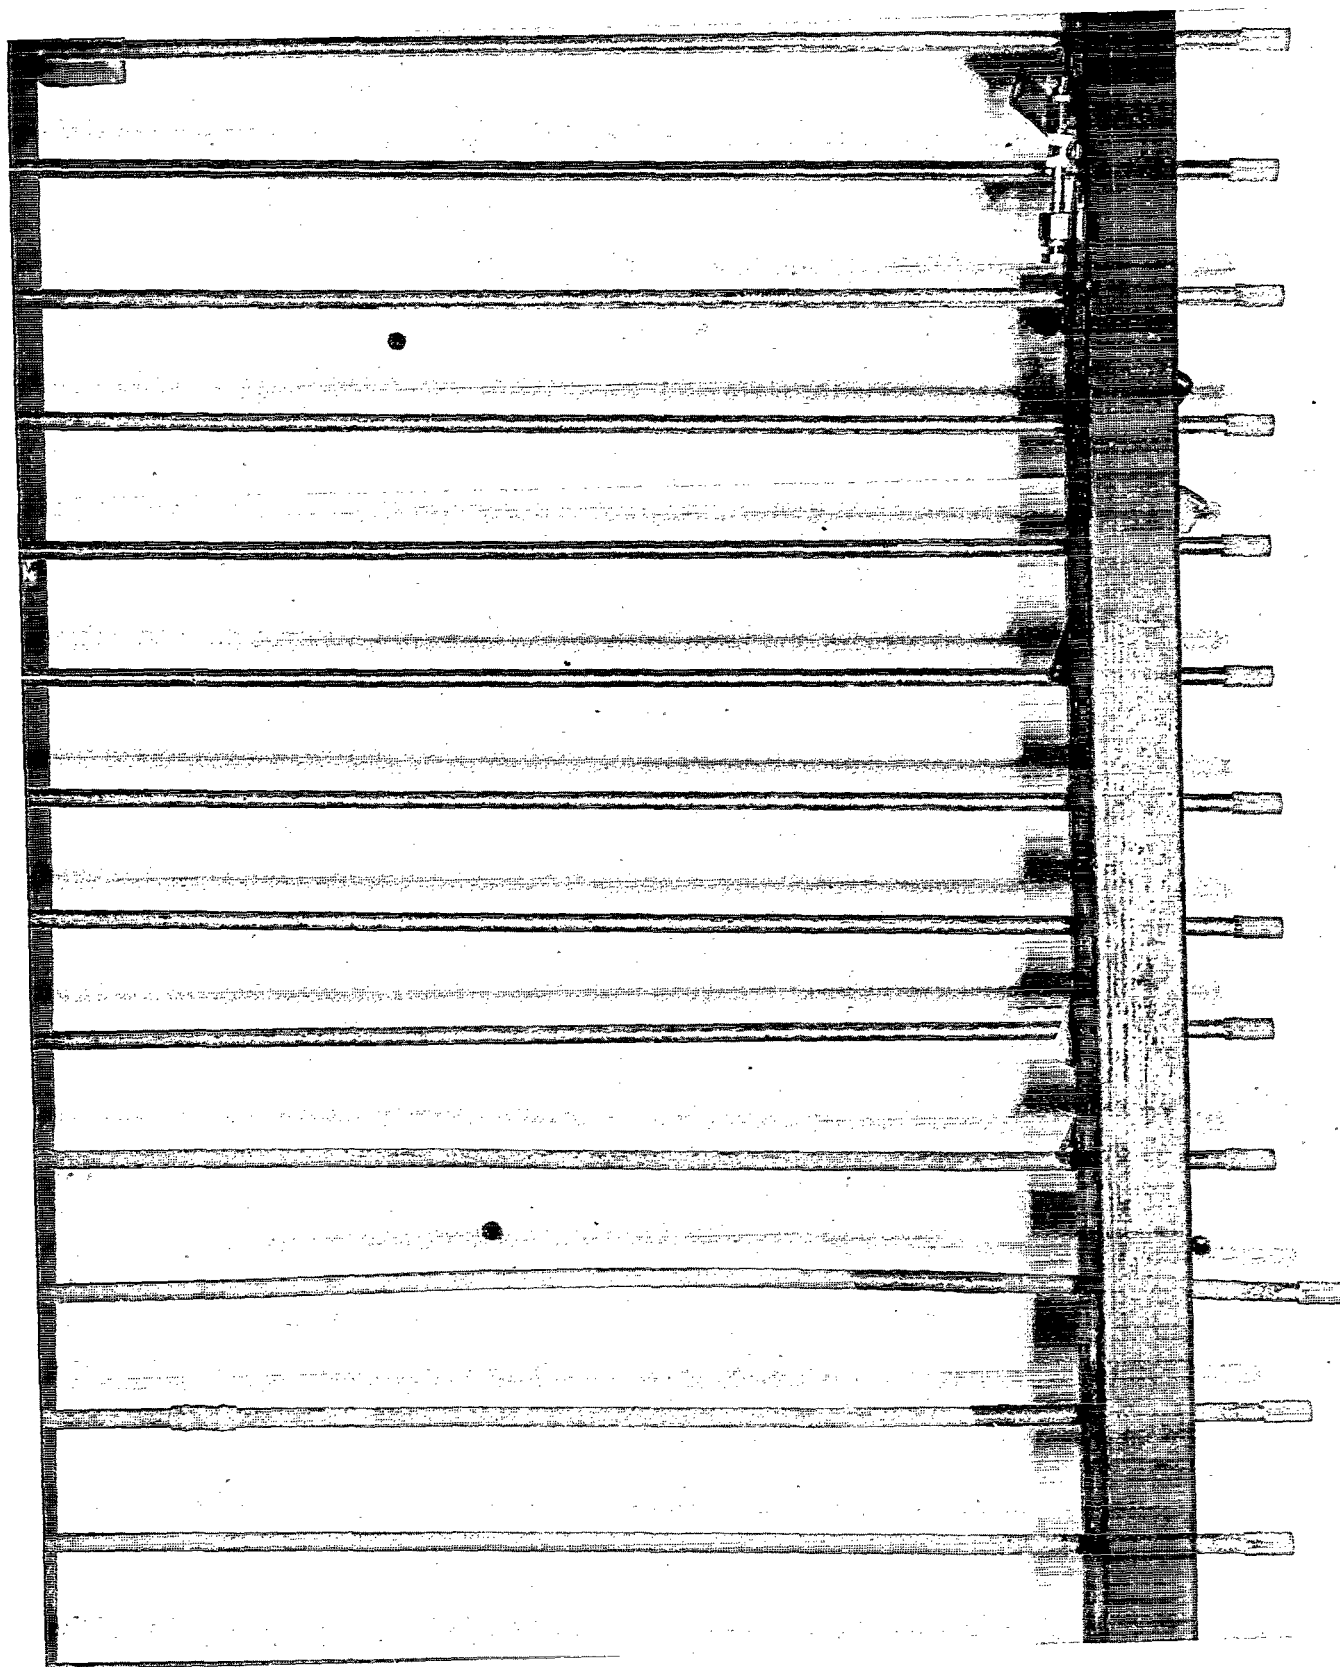
Figure 5. Tubing Samples in Sheltered Section of Rack Number 3 After 3 Months' Exposure
(The four organic-zinc-coated samples are shown at the bottom) (Sheet 1 of 2)

The general appearance of several of the coated and bare test specimens in Racks Number 3 and 4 is shown in Figures 5 through 10. Figure 5, Sheet 1 shows the underside of a group of bare and coated tubing samples in the sheltered section of Rack Number 3 after approximately 3 months' exposure. The four coated samples in Figure 5, Sheet 1 are the tubes removed from Complex 34 and brush-coated with organic-zinc paint. Two of the tubes also have short sections wrapped with self-sealing polyethylene tape. It can be noted that three of the coated tubes have bare spots near the end caps. These bare spots did not show active corrosion during the total exposure period of approximately 30 months, evidently because of sacrificial protection afforded by the zinc coating. The dark spots on the bare tubes are accumulations of corrosion products around active pits.

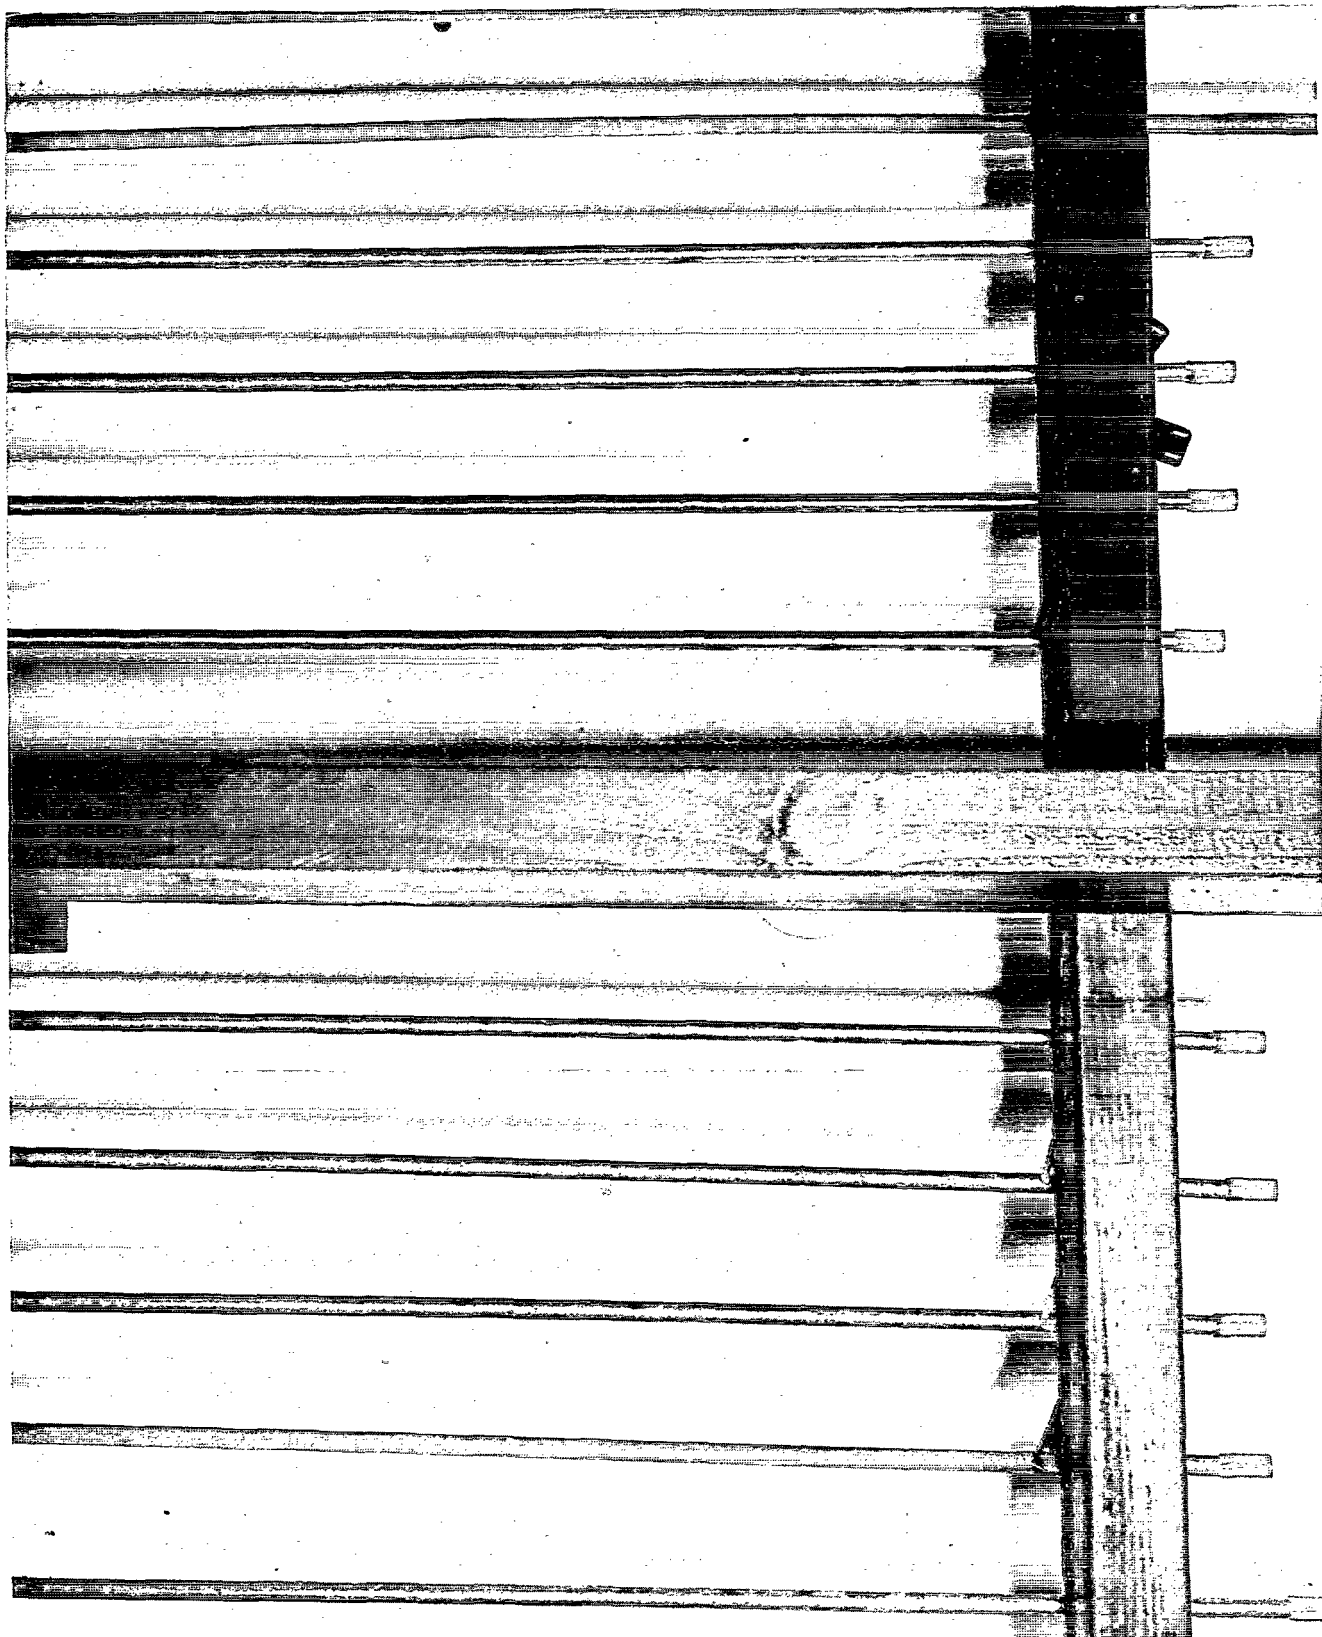
Figure 5. Tubing Samples in Sheltered Section of Rack Number 3 After 3 Months' Exposure
(The inorganic-zinc-coated sample is shown at bottom) (Sheet 2 of 2)

Similar conditions are shown on the bare samples illustrated in Figure 5, Sheet 2. The single coated sample at the bottom of the photograph has the inorganic-zinc paint applied over a sandblasted surface. This coating remained intact after 30 months' exposure.

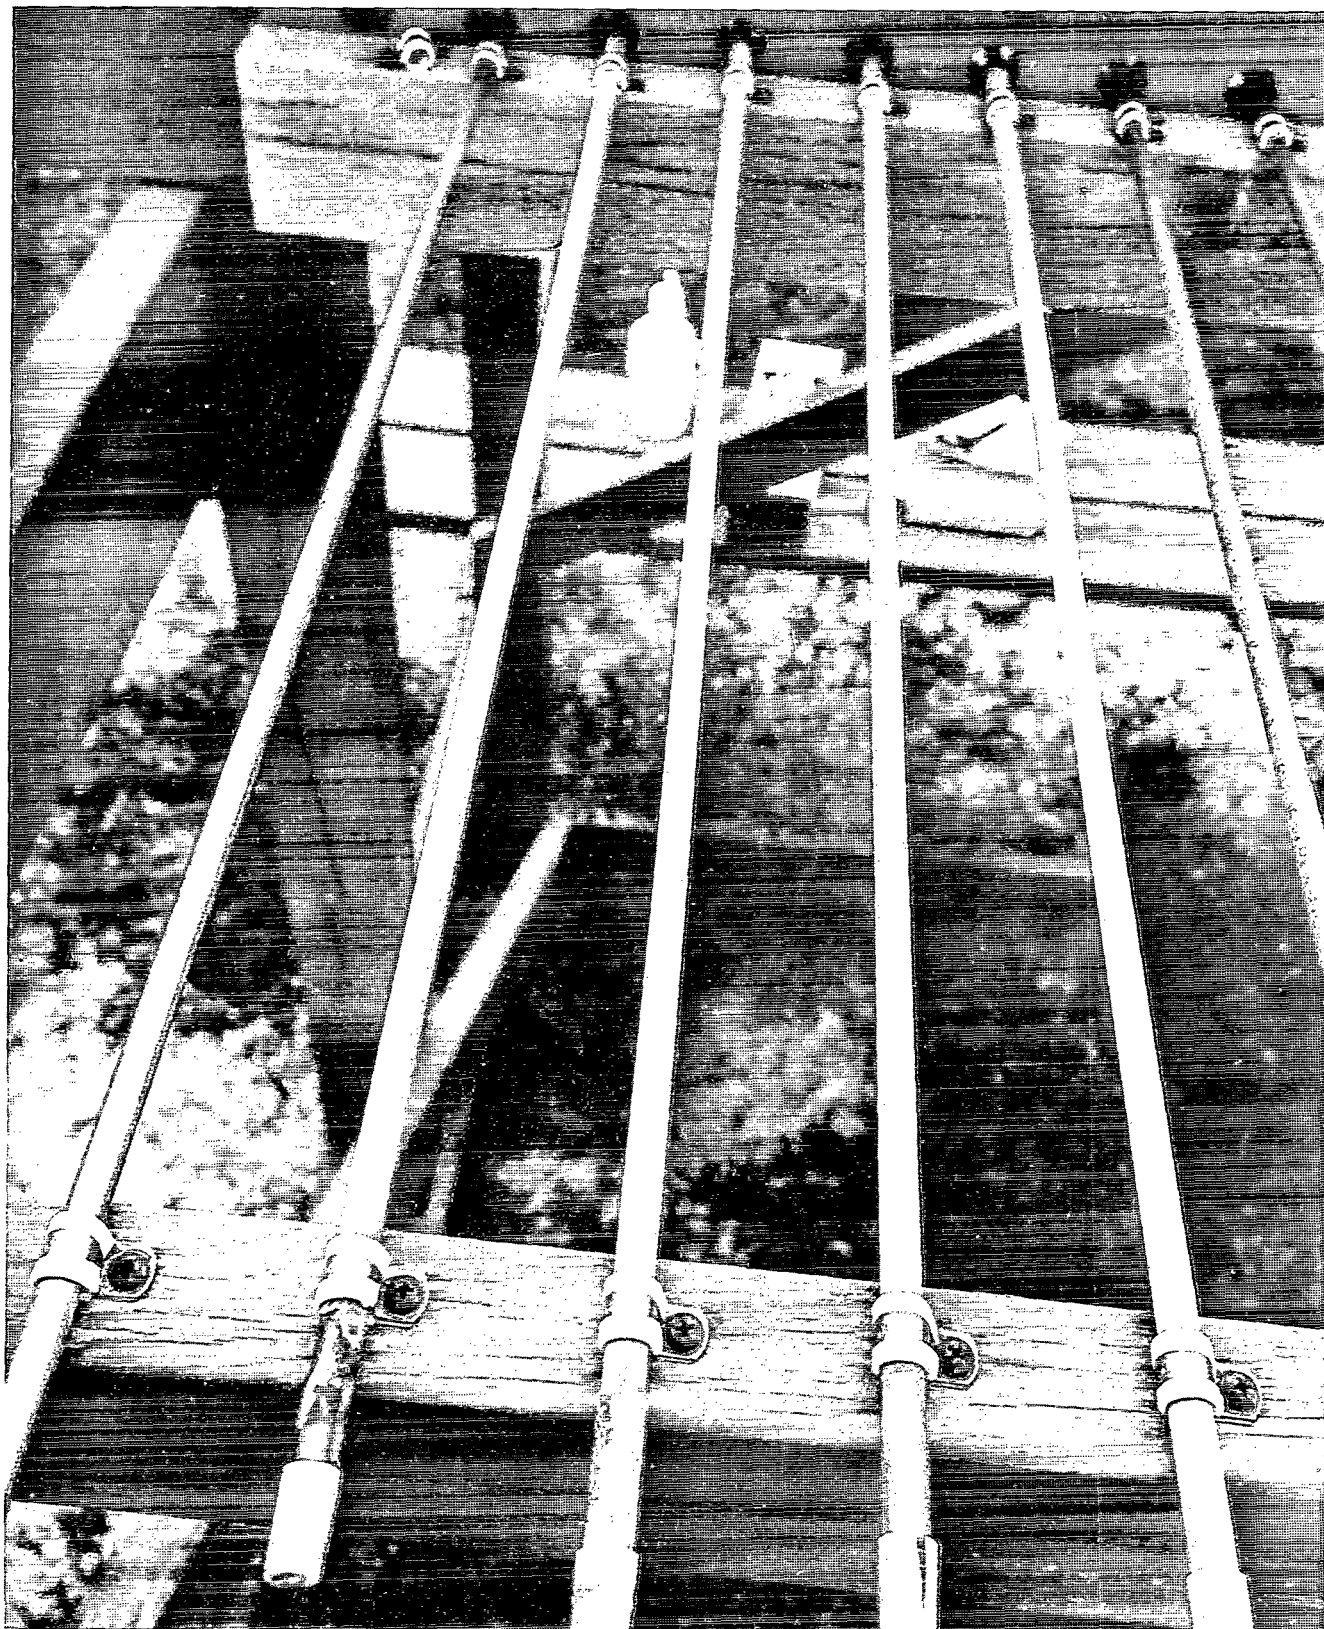
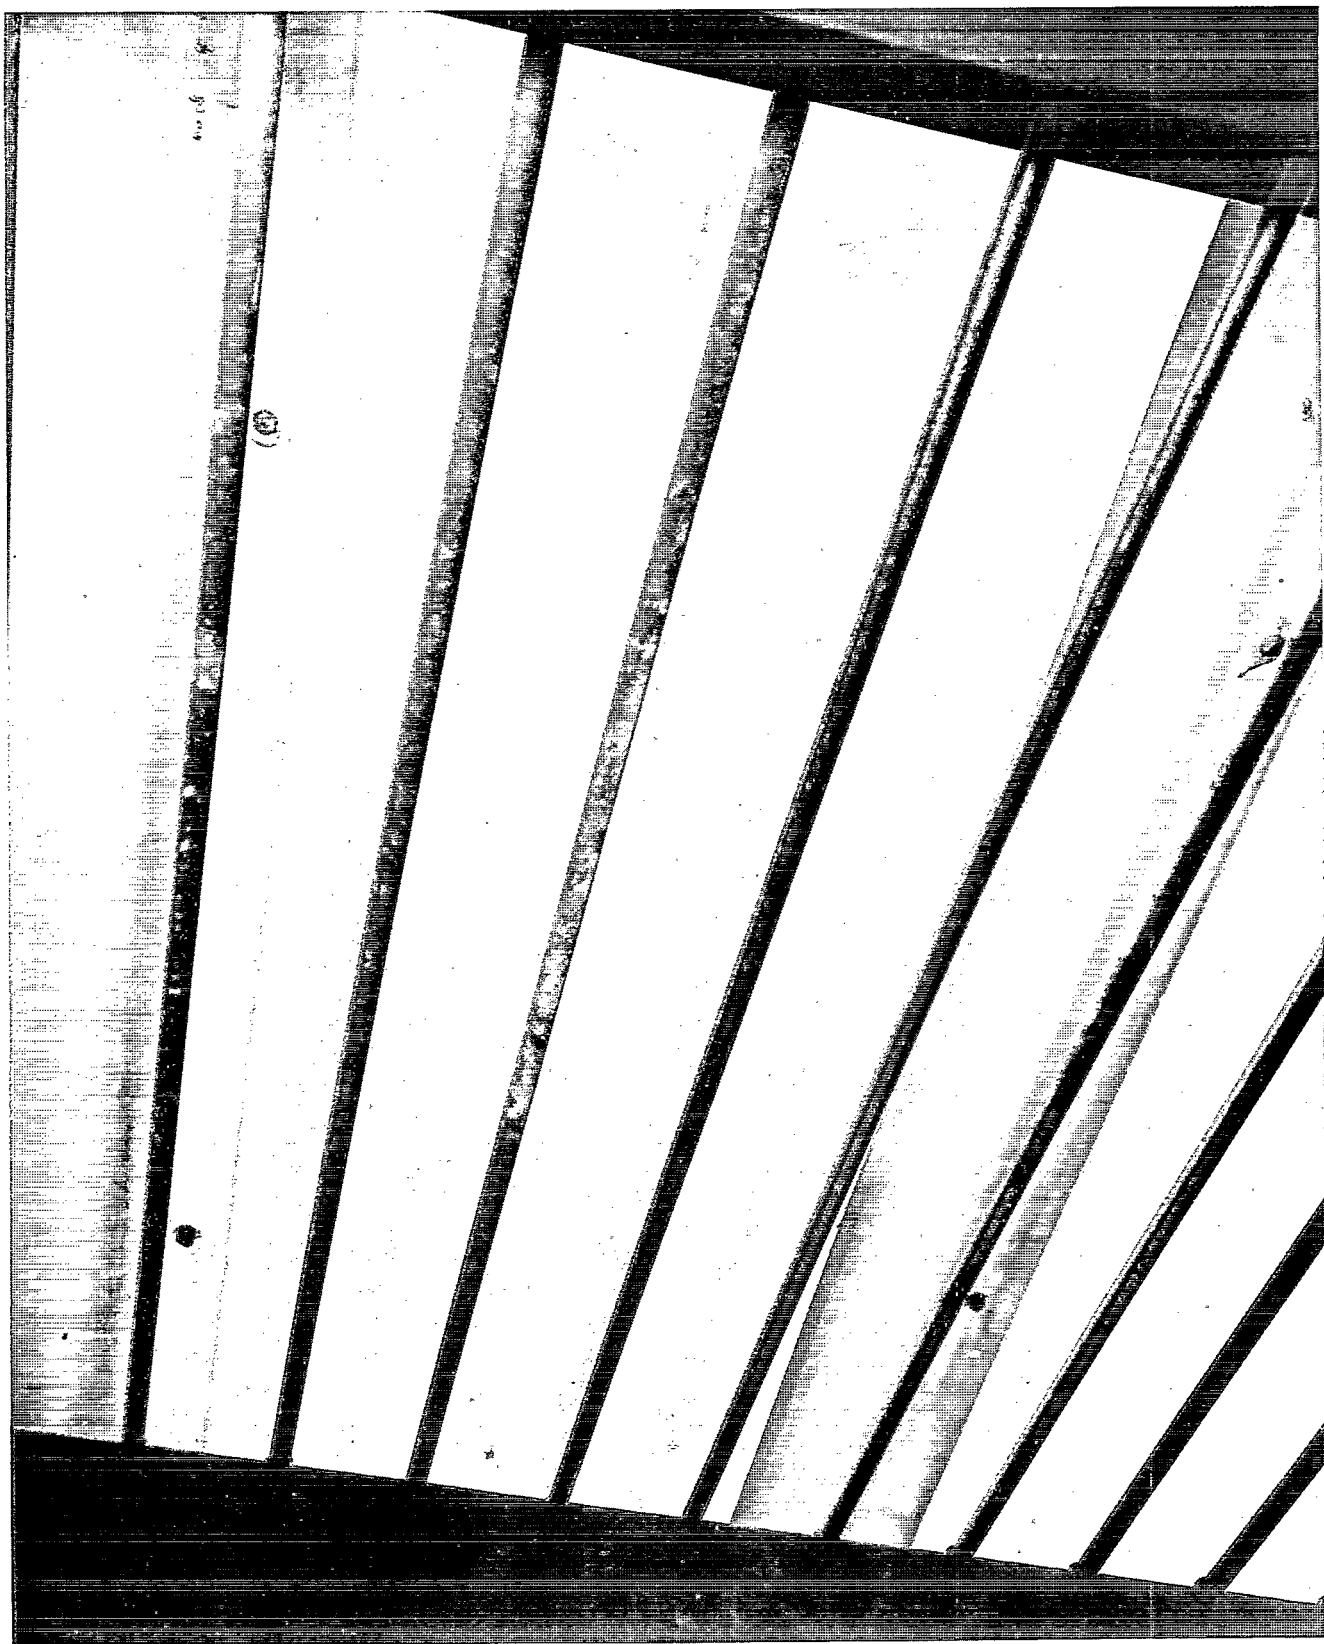
Figures 6 and 7 show other bare and organic-zinc-coated tubes in the exposed and sheltered sections, respectively, of Rack Number 3 after approximately 30 months' exposure. The coating was applied to "new" tubing samples that had been cleaned with the phosphoric acid wash. These samples, including intentional bare areas (or tape-wrapped areas) near the end caps, remained essentially free of corrosion during this exposure period.

Figure 6. Bare and Organic-Zinc-Coated Samples in Exposed Section of Rack Number 3
(After approximately 30 months' exposure)

Figure 7. Bare and Organic-Zinc-Coated Samples in Sheltered Section of Rack Number 3
(After approximately 30 months' exposure)

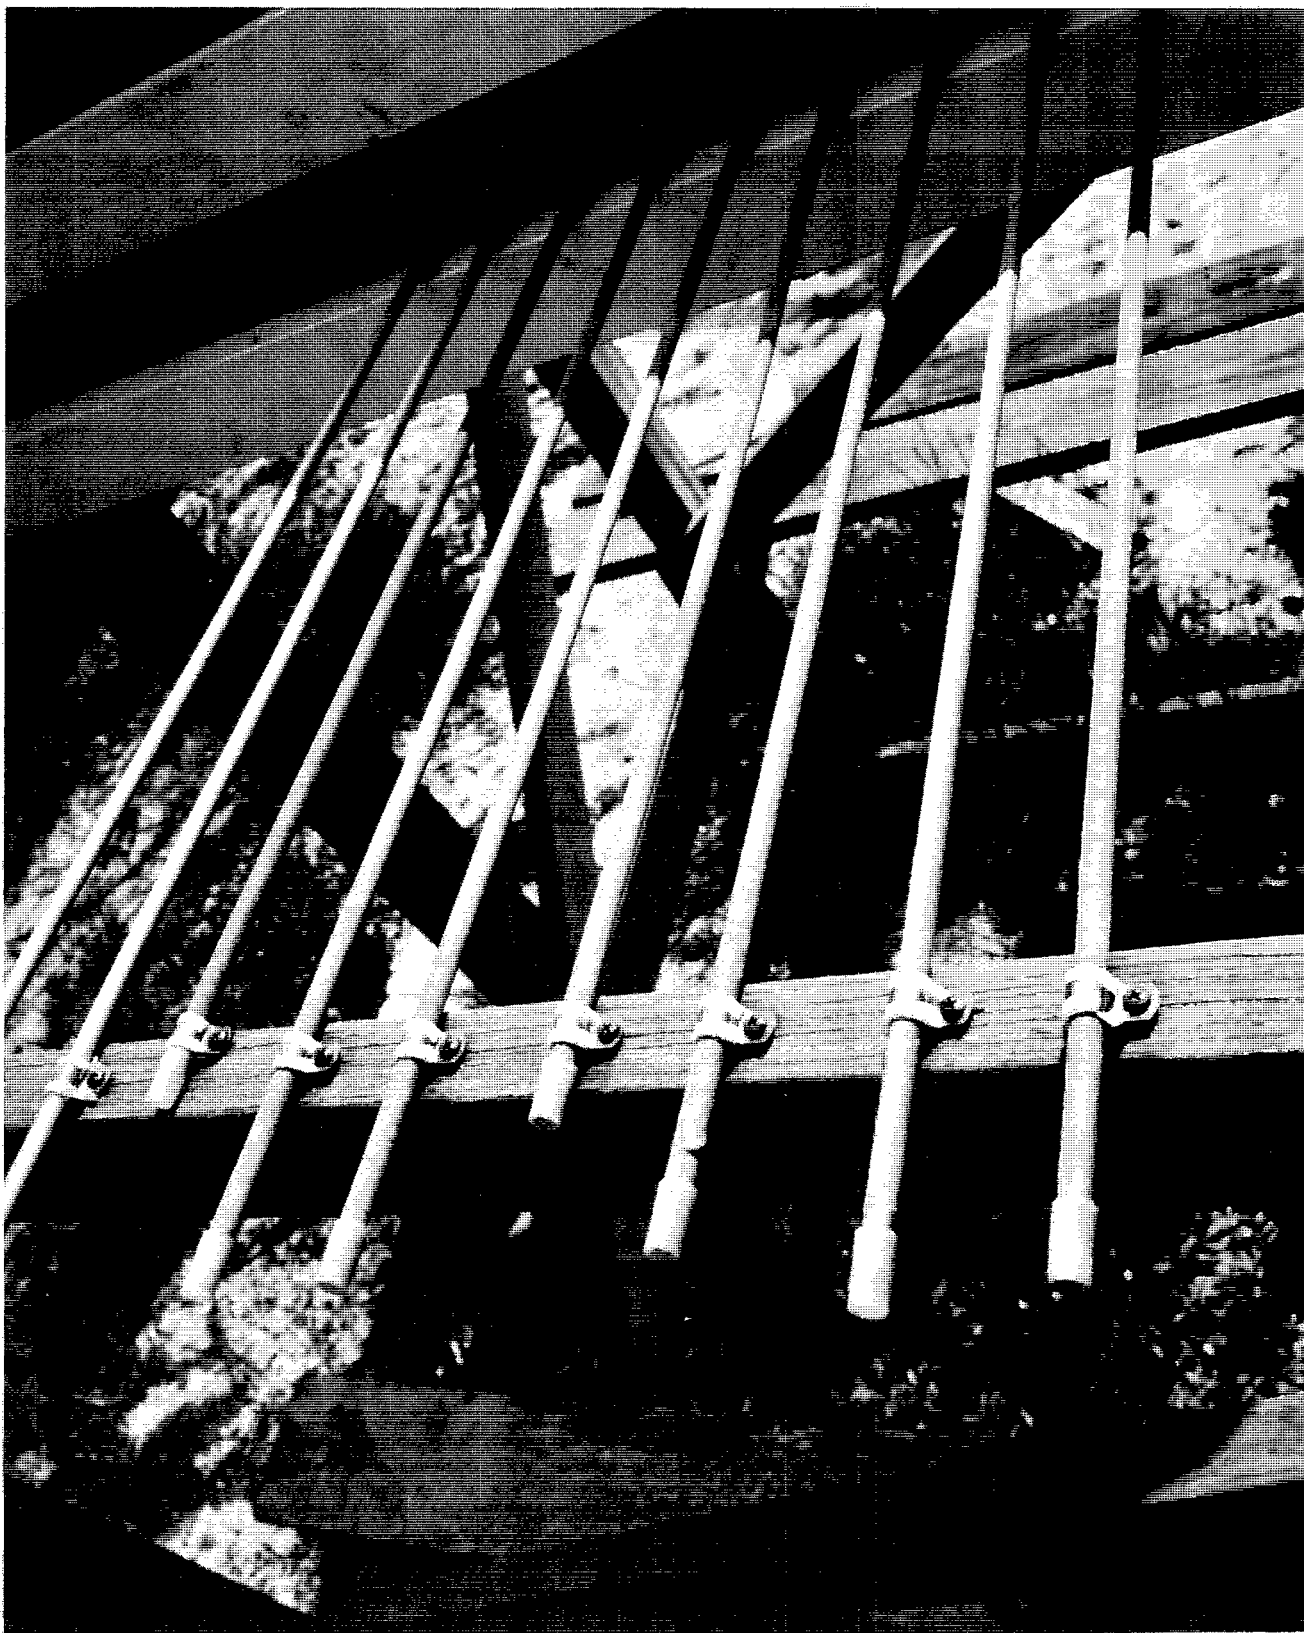
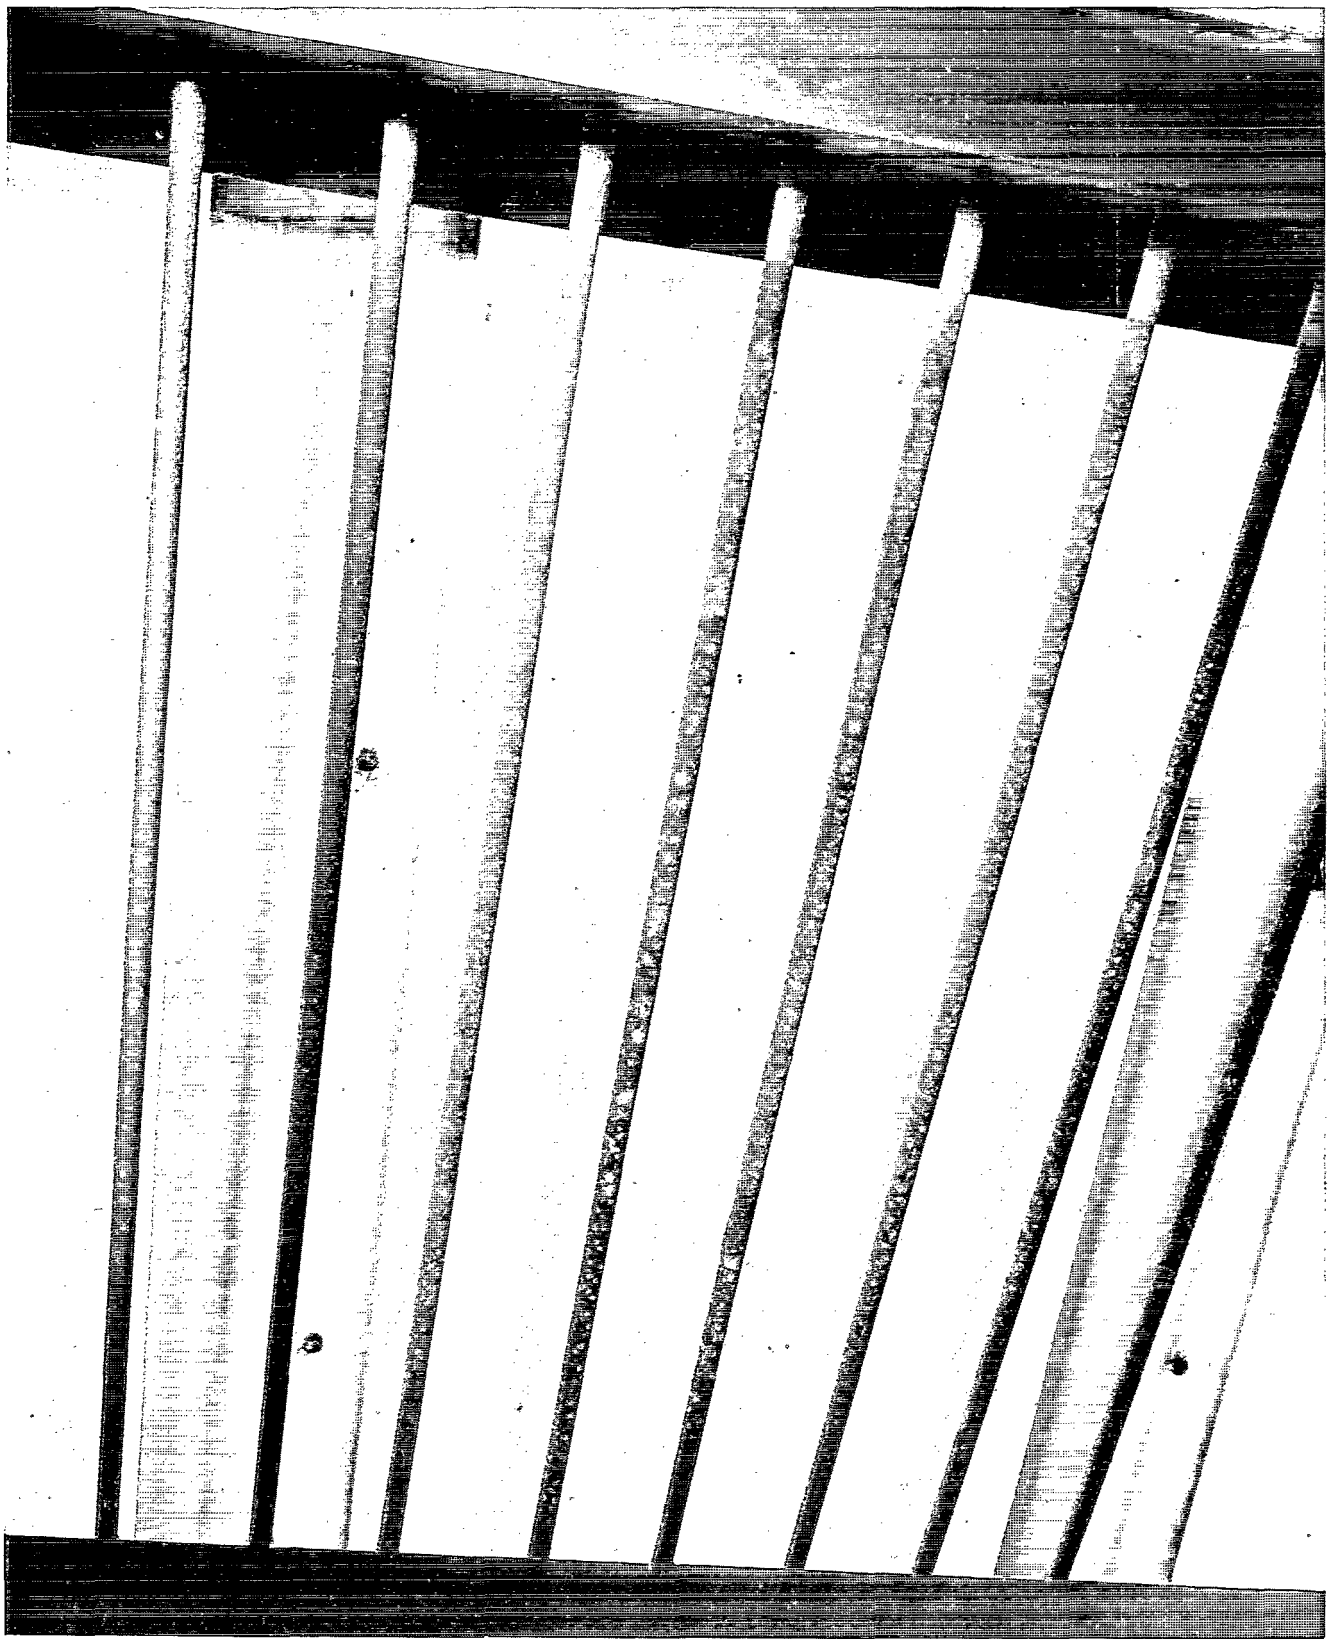
These coatings have remained entirely intact and protective to the stainless steel substrate during the 10 months of exposure. Slight flaking of the organic-zinc paint has occurred on the sheltered side of two of the samples, at the X-shaped scribe marks in the coatings. However, the organic-zinc coating has continued to protect the substrate in these areas.

Figure 8. Coated Samples in Exposed Section of Rack Number 4 After 10 Months' Exposure
(Two aluminum-filled coatings and one aluminum-zinc-filled coating on left;
remaining six samples are organic-zinc-paint-coated)

Figure 9. Coated Samples in Sheltered Section of Rack Number 4 After 10 Months' Exposure
(One aluminum-filled coating and one aluminum-zinc-filled coating on left;
remaining six samples are organic-zinc-paint-coated)

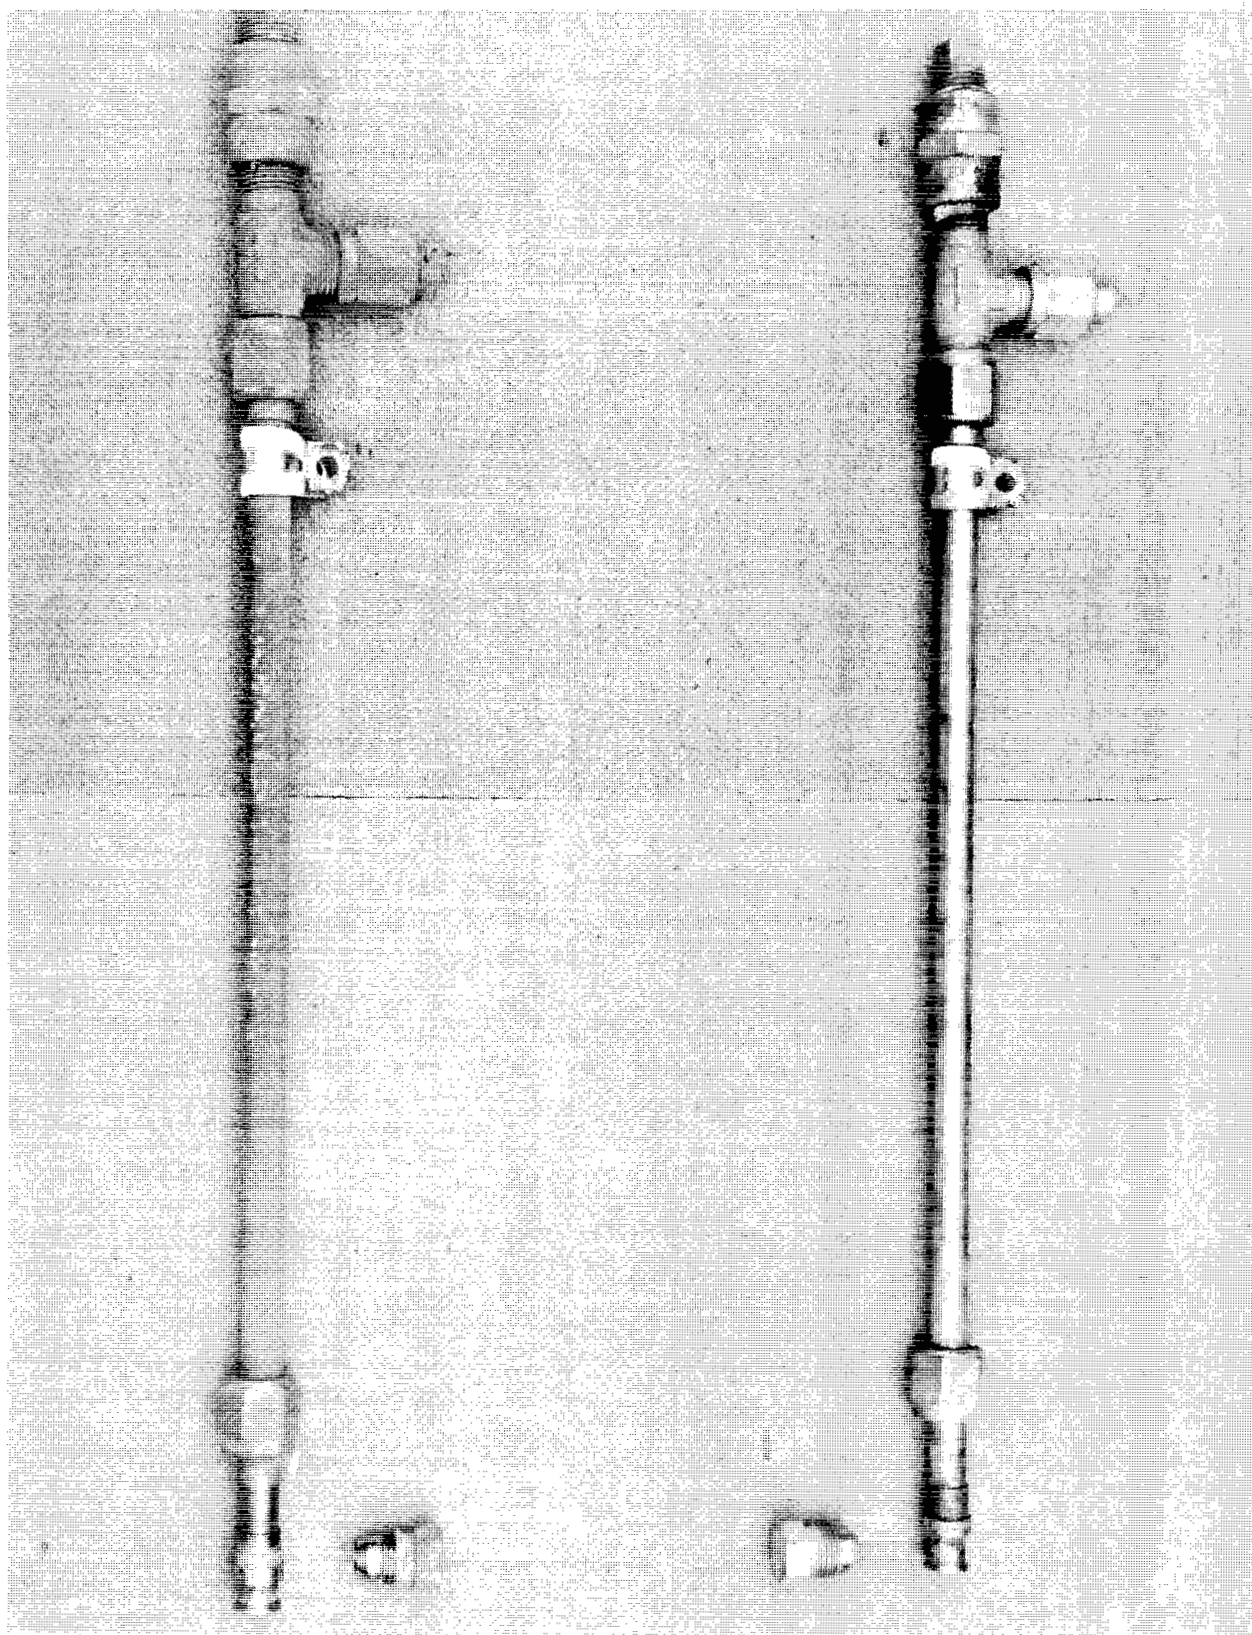
Figure 10. Coated and Bare Tubing Assemblies After 12 and 14 Months' Exposure, Respectively, in the Sheltered Section of Rack Number 4 (Inorganic, zinc-rich paint applied over sandblasted surface)

Figure 10 shows two tubing assemblies removed from the sheltered section of Rack Number 4. The sample on the left side has been sandblasted and coated with inorganic-zinc paint, and was exposed at the corrosion test site for 12 months. The bare sample was exposed for 14 months. The B-nuts and end plugs were removed, exposing the flared ends of both samples. The zinc-coated sample showed no evidence of corrosion. The bare sample had undergone considerable crevice corrosion in the B-nut area, and there were large corrosion deposits under both the B-nut and sleeve. Several longitudinal cracks were noted in the sleeve. The extent

of the stress-corrosion cracking is this B-nut sleeve is described in more detail in subsequent paragraphs herein. It is evident that the zinc coating affords protection against crevice corrosion and stress-corrosion cracking in the area of tubing attachments.

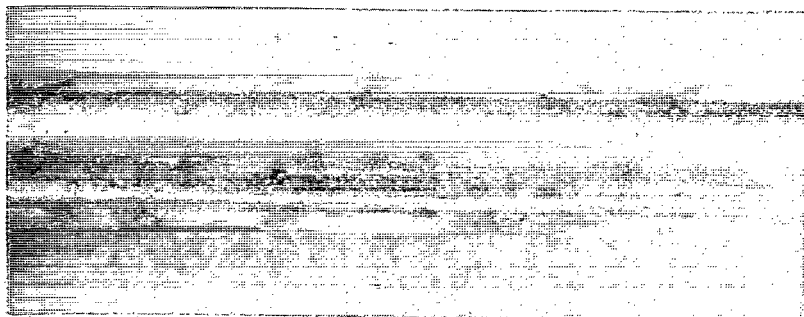
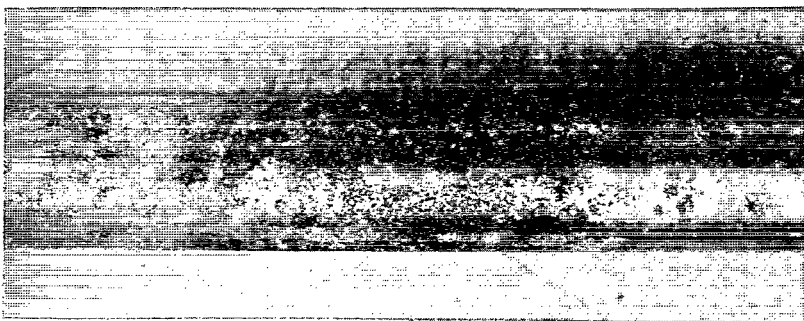
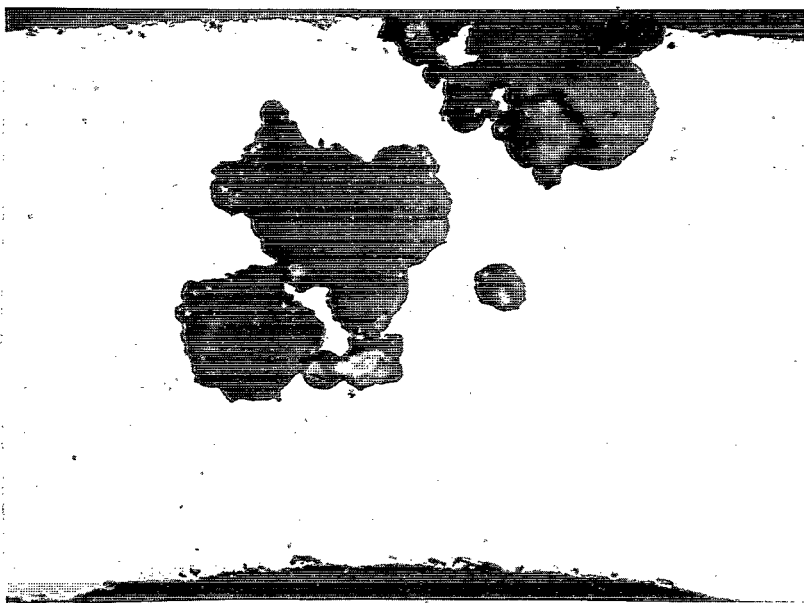
Figure 11. Surface Characteristics and Pit Depth of Type 316L Exposure Sample

Actually, the deepest pits found to date in any of the samples have been in Type 316L and in the Type 316 (MSFC 10M01734), as is shown in Figures 11 and 18. This is not to suggest that Type 316 has a higher pitting rate than the other grades; in another Type 316 sample (Figure 15), no deep pits were found. The evidence cited here does suggest that no single austenitic stainless steel of the grades tested in this program is significantly better than the others for the fluid-systems applications in an environment of the KSC type.

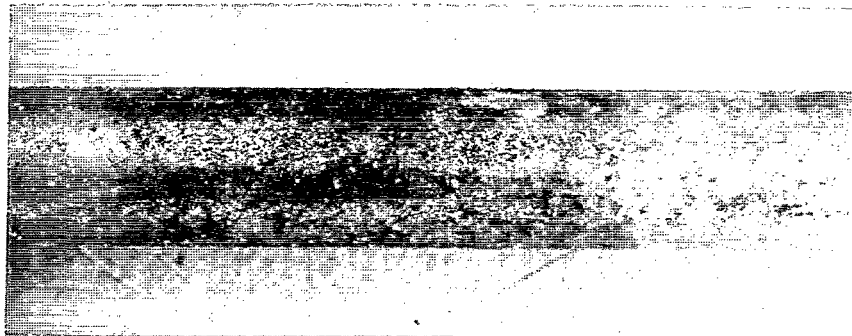
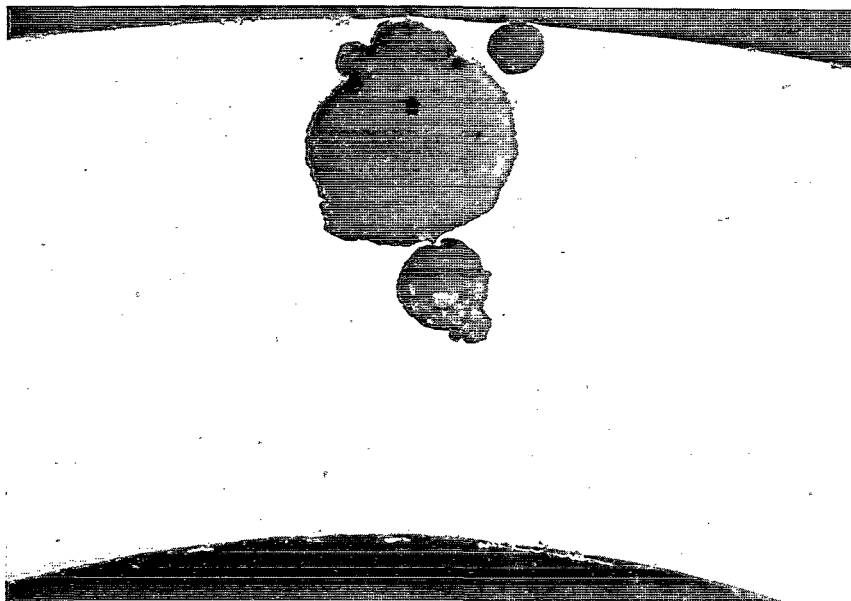
Figure 18. Surface Characteristics and Pit Depth of Type 316 (MSFC 10M01734)
Exposure Sample

Cross-Section of Tubing Wall in Deepest Pit Area
(Tubing Wall Thickness 0.125 cm (0.049"))

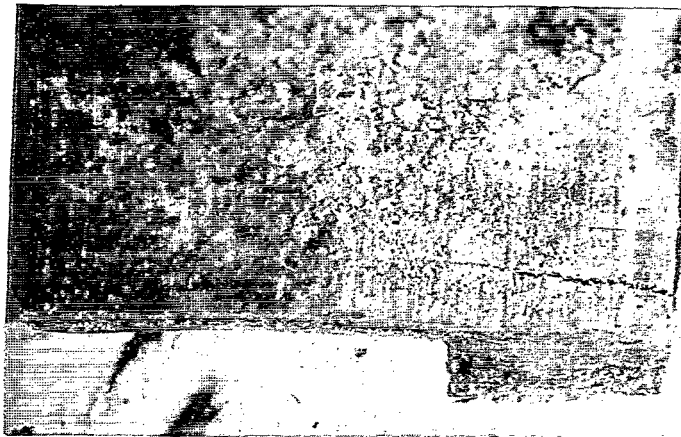
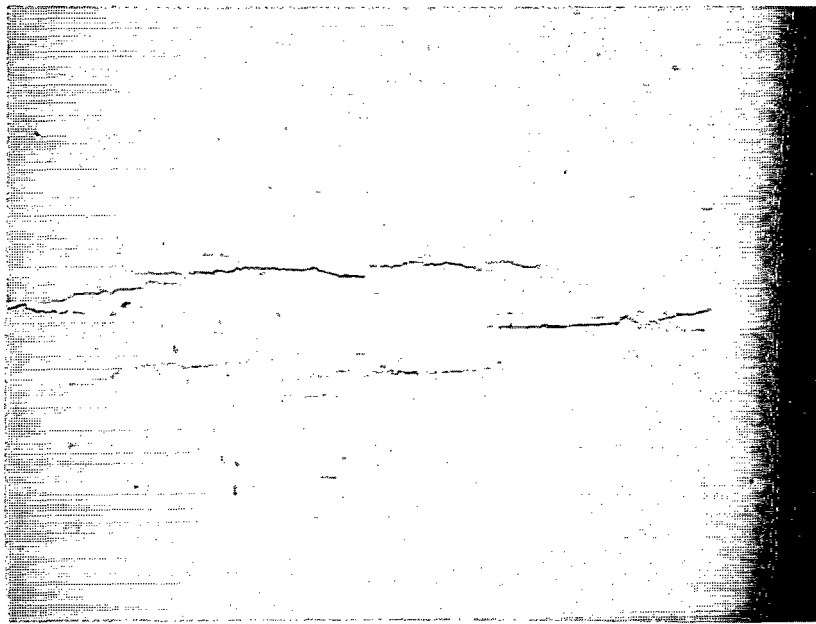
Figure 21. Stress-Corrosion Cracking in Type 303 B-Nut Sleeve from Bare Tubing Assembly Removed from Rack Number 4 After 14 Months' Exposure

Figure 21 shows a photomicrograph of this inner surface, with the stress-corrosion cracks and corrosion products, and a photomicrograph of a longitudinal microsection cut from the sleeve and prepared metallographically. In the photomicrograph, the branching nature of the stress-corrosion cracks can be seen. The small "stringers" in the microstructure are sulfide inclusions which are typical of the Type 303 grade. Although the B-nuts and other major fittings used in the tubing assembly were the 316 grade (Type K), the B-nut sleeve (the identity of which was not disclosed by markings) was Type 303, as was confirmed by chemical analysis. It is probable that Type 303 accounts for most of the stress-corrosion failures of tubing fittings that have occurred at KSC.

Sleeve Inner Surface

Longitudinal Microsection

This characteristic was clearly demonstrated during the recent examination, in the KSC Materials Testing Branch, of the B-nut sleeve shown in Figure 21. During examination of the cracked areas with a low-power microscope, bubbling of liquid retained within one of the larger cracks was observed. This activity was occurring about 10 days after the sample had been removed from the corrosion test site and brought to the laboratory. Some of the liquid was absorbed into a piece of pH-sensitive paper (Hydrion Paper), with which the pH of a test solution is indicated by color change. The pH of the "stress-corrosion liquor" was determined, by this means, to be in the range of 1.5 to 2.0. Similar activity undoubtedly occurs in corrosion pits particularly those that have grown to larger size within tubing walls. Corrosion activity can continue in these sites even after the parts have been removed from the primary corrosive environment. For example, pitting of some of the stainless steel tubing lines on one of the mobile launchers moved from the pad to a bay in the VAB could continue to be active there as long as sufficient moisture was present in the atmosphere to prevent drying of the pits.
